DEPARTMENT OF TRANSPORTATION**DIVISION OF ENGINEERING SERVICES**

Office of Structural Materials

Contract #: 04-0120F4Cty: SF/Ala Rte: 80 PM: 13.2/13.9File #: 69.28**WELDING INSPECTION REPORT****Resident Engineer:** Siegenthaler, Peter**Address:** 333 Burma Road**City:** Oakland, CA 94607**Report No:** WIR-020885**Date Inspected:** 12-Feb-2011**Project Name:** SAS Superstructure**OSM Arrival Time:** 1900**Prime Contractor:** American Bridge/Fluor Enterprises, a JV**OSM Departure Time:** 700**Contractor:** Zhenhua Port Machinery Company, Ltd (ZPMC), Changxing Island **Location:** Shanghai, China**CWI Name:** See below**CWI Present:** Yes No**Inspected CWI report:** Yes No N/A**Rod Oven in Use:** Yes No N/A**Electrode to specification:** Yes No N/A**Weld Procedures Followed:** Yes No N/A**Qualified Welders:** Yes No N/A**Verified Joint Fit-up:** Yes No N/A**Approved Drawings:** Yes No N/A**Approved WPS:** Yes No N/A**Delayed / Cancelled:** Yes No N/A**Bridge No:** 34-0006**Component:** OBG Components**Summary of Items Observed:**

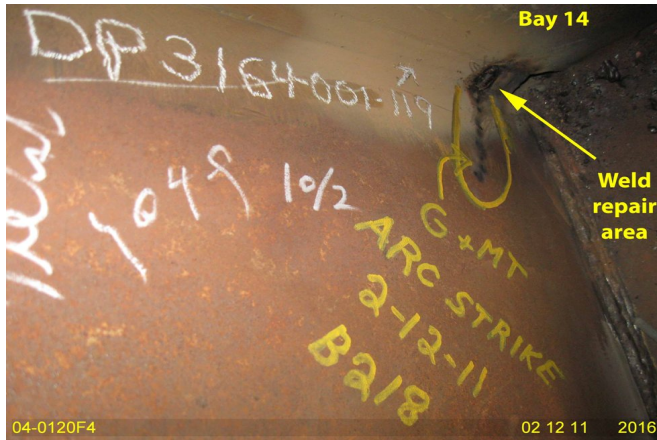
SMAW repair welding of weld joint DP3164-001-119 located on PCMK OBG 14E, longitudinal diaphragm to transverse diaphragm. Welder was identified as 066422. QC was identified as QC1. Assisting QC1 at this location and appearing to be monitoring the welding operation and recording data was QCA1, who was not a CWI. Weld variables recorded by QCA1 appeared to comply with WPS-345-SMAW-3G(3F)-FCM-repair as verbally identified by QCA1. QCA1 informed this QA Inspector that the repair was the result of ZPMC visual testing. Intermittent arc strikes approximately 120mm long were observed on the longitudinal diaphragm adjacent to weld joint DP3164-001-119. This QA Inspector clearly marked the visual indication in yellow paint with G+MT, signifying 'grind smooth and magnetic particle test' and informed QCA1 of the arc strike and marking. See the photo below. QCA1 informed this QA Inspector that the arc strike would be corrected in a manner compliant with

the relevant contract documents.
